# Inspection Report

805 Trail mark Dr  
St Augustine, FL 32092

Inspection Type Indoor Air Quality Assessment  
Others Present Tenant Property Occupied Occupied  
Building Type Amenity Center Garage

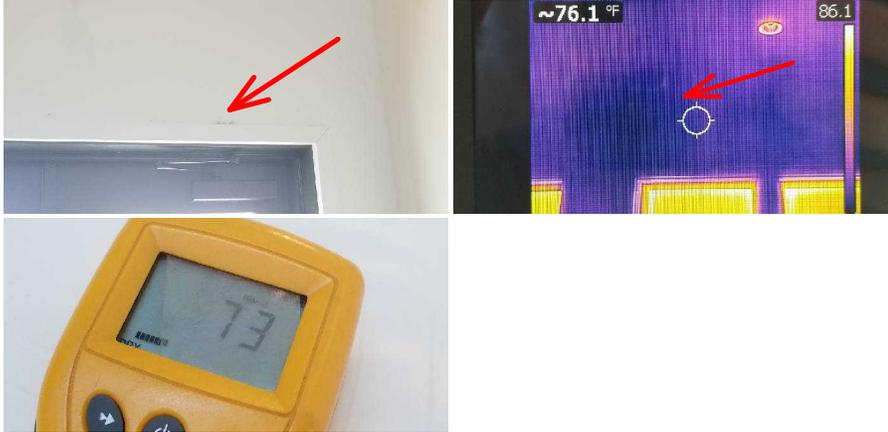
Gym Building Assessment  
 Defective Moisture Condition No Elevated Moisture Observed - Water stains present at rear wall below clerestory windows. Interior surfaces (accessible walls, floors, and ceilings) were assayed using Infra Red Thermography and a moisture meter. No Moisture - No evidence of elevated moisture conditions was observed.

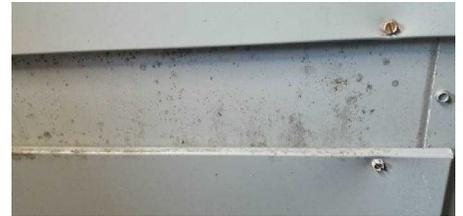
Defective Visible Suspect Mold Growth Observed - Less than 10 square feet of visible growth at surfaces in mechanical room. This type of surface growth is typically indicative of elevated humidity resulting in condensation on cool surfaces.

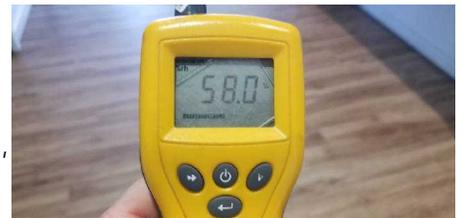
Defective Temp/Humidity Condition Elevated Relative Humidity - RH above 55% in any indoor space is considered "inappropriate" according to EPA and ACGIH guidelines. Elevated RH raised Dew Point and creates more condensation on cool surfaces, which can provide moisture source needed to support mold growth.

The general tendency towards higher indoor relative humidity are attributed to an imbalance between supply and return air volumes placing the building in a negative pressure when AC is operational. Ongoing infiltration of hot/humid outdoor/attic air results in added overall grains of moisture indoors.

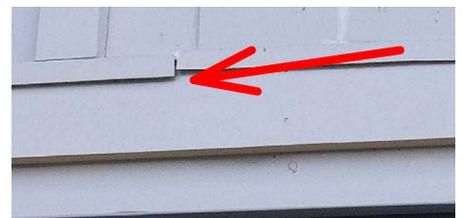
Defective Adjacent Exterior Wall Evaluation - Z flashing at upper wall skirt board at rear was improperly installed with no lap or sealant at the lap. Water intrusion occurs at this location causing the staining at rear wall.

1. Replace sections of Z flashing at skirt trim to assure proper lap at joints. Seal all lap joints using polyurethane caulk.
2. Seal all exterior casing to door frames using polyurethane caulk.
3. Consult with a qualified HVAC contractor to conduct a test and balance assessment on AC systems and assure proper balance between supply and return air at all locations. Seal all duct penetrations through ceilings using mastic, and provide properly sized supply/return in mechanical room.

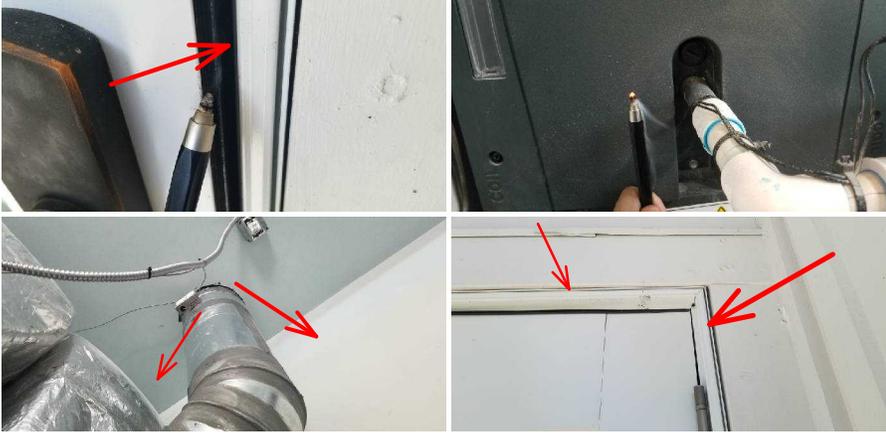
Other Observations General Pressurization - Overall buil ding pressurization was tested using a smoke pin to identify general tendencies for air movement either inward or outward. A consistent tendency towards inward air movement or negative pressurization was observed.

Exterior door casings were general ly found to be unseal ed and improper ly instal led al lowing for unhindered ingress of outside air.

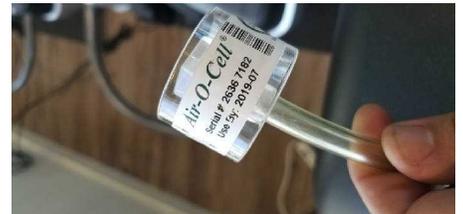
Sample 1 Indoor - Sample NOT ELEVATED per Lab report attached.

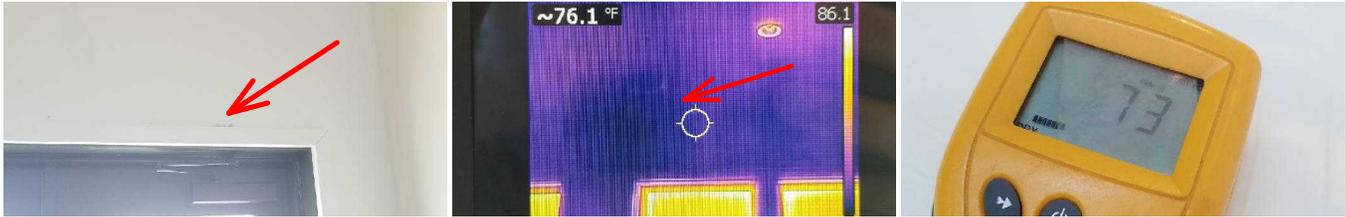
1. Gym Building Assessment Moisture Condition No Elevated Moisture Observed - Water stains present at rear wall below clerestory windows. Interior surfaces (accessible walls, floors, and ceilings) were assayed using Infra Red Thermography and a moisture meter. No Moisture - No evidence of elevated moisture conditions was observed.

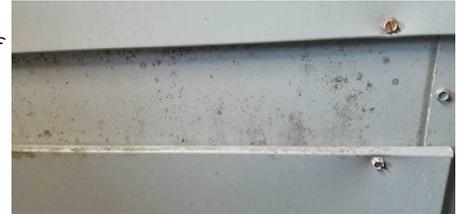
2. Gym Building Assessment Visible Suspect Mold Visible - Less than 10 square feet of visible growth at surfaces in mechanical room. This type of surface growth is typically indicative of elevated humidity resulting in condensation on cool surfaces.

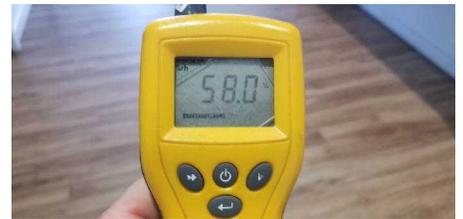
3. Gym Building Assessment Temp/Humidity Condition Elevated Relative Humidity - RH above 55% in any indoor space is considered "inappropriate" according to EPA and ACGIH guidelines. Elevated RH raised Dew Point and creates more condensation on cool surfaces, which can provide moisture source needed to support mold growth.

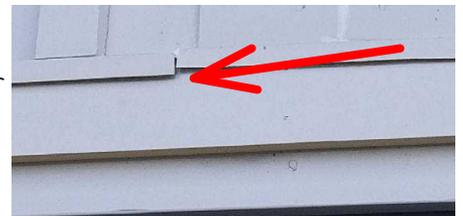
4. Gym Building Assessment Adjacent Exterior Exterior Wall Evaluation - Z flashing at upper wall skirt board at rear was improperly installed with no lap or sealant at the lap. Water intrusion occurs at this location causing the staining at rear wall.

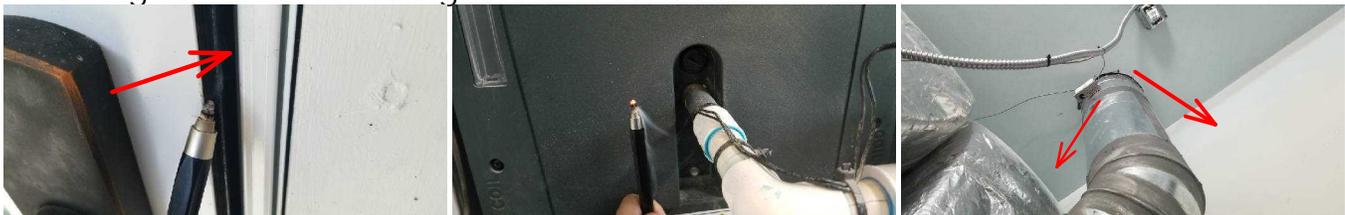
5. Gym Building Assessment Other Observations General Pressurization - Overall building pressurization was tested using a smoke pin to identify general tendencies for air movement either inward or outward. A consistent tendency towards inward air movement or negative pressurization was observed.

Exterior door casings were generally found to be unsealed and improperly installed allowing for unhindered ingress of outside air.
