# Inspection Report

805 Trail mark Dr  
St Augustine, FL 32092

Inspection Type Indoor Air Quality Assessment  
Others Present Tenant Property Occupied Occupied  
Building Type Amenity Center Garage

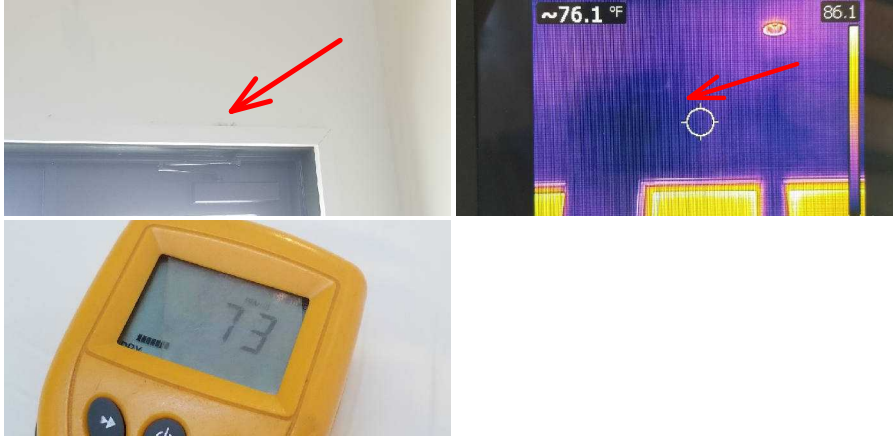
Gym Building Assessment  
 Defective Moisture Condition No Elevated Moisture Observed - Water stains present at rear wall below clerestory windows. Interior surfaces (accessible walls, floors, and ceilings) were assayed using Infra Red Thermography and a moisture meter. No Moisture - No evidence of elevated moisture conditions was observed.

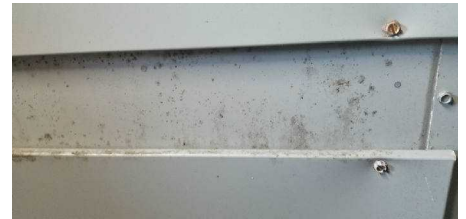
Defective Visible Suspect Mold Growth Observed - Less than 10 square feet of visible growth at surfaces in mechanical room. This type of surface growth is typically indicative of elevated humidity resulting in condensation on cool surfaces.

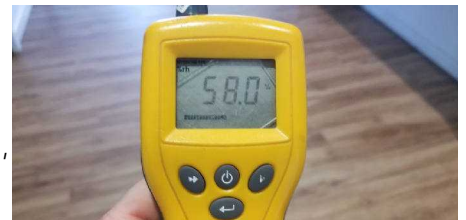
Defective Temp/Humidity Condition Elevated Relative Humidity - RH above 55% in any indoor space is considered "inappropriate" according to EPA and ACGIH guidelines. Elevated RH raised Dew Point and creates more condensation on cool surfaces, which can provide moisture source needed to support mold growth.

The general tendency towards higher indoor relative humidity are attributed to an imbalance between supply and return air volumes placing the building in a negative pressure when AC is operational. Ongoing infiltration of hot/humid outdoor/attic air results in added overall grains of moisture indoors.

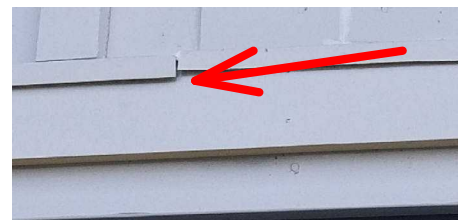
Defective Adjacent Exterior Wall Evaluation - Z flashing at upper wall skirt board at rear was improperly installed with no lap or sealant at the lap. Water intrusion occurs at this location causing the staining at rear wall.

1. Replace sections of Z flashing at skirt trim to assure proper lap at joints. Seal all lap joints using polyurethane caulk.
2. Seal all exterior casing to door frames using polyurethane caulk.
3. Consult with a qualified HVAC contractor to conduct a test and balance assessment on AC systems and assure proper balance between supply and return air at all locations. Seal all duct penetrations through ceilings using mastic, and provide properly sized supply/return in mechanical room.

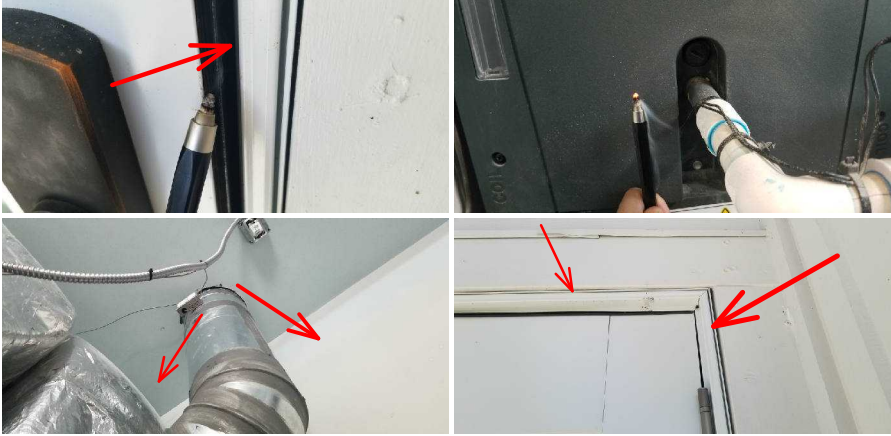
Other Observations General Pressurization - Overall building pressurization was tested using a smoke pin to identify general tendencies for air movement either inward or outward. A consistent tendency towards inward air movement or negative pressurization was observed.

Exterior door casings were generally found to be unsealed and improperly installed allowing for unhindered ingress of outside air.

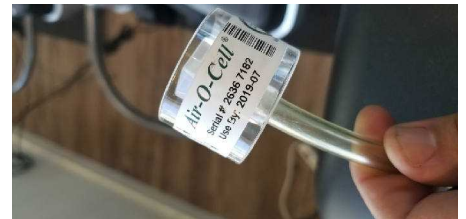
Sample 1 Indoor - Sample NOT ELEVATED per Lab report attached.

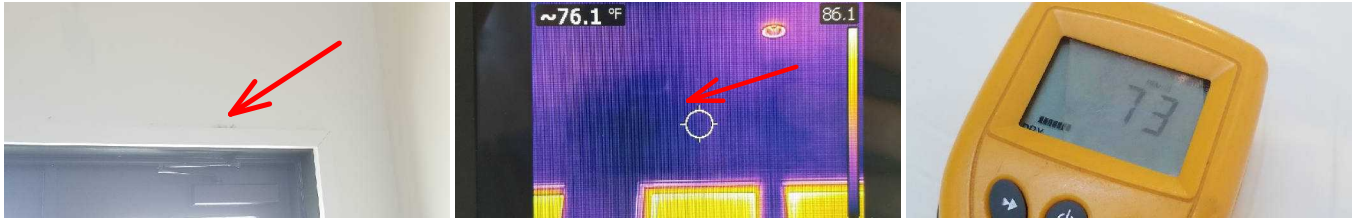
1. Gym Building Assessment Moisture Condition No Elevated Moisture Observed - Water stains present at rear wall below clerestory windows. Interior surfaces (accessible walls, floors, and ceilings) were assayed using Infra Red Thermography and a moisture meter. No Moisture - No evidence of elevated moisture conditions was observed.

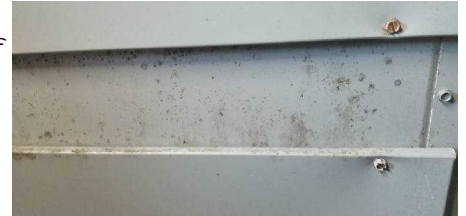
2. Gym Building Assessment Visible Suspect Mold Visible Suspect Mold Growth Observed - Less than 10 square feet of visible growth at surfaces in mechanical room. This type of surface growth is typically indicative of elevated humidity resulting in condensation on cool surfaces.

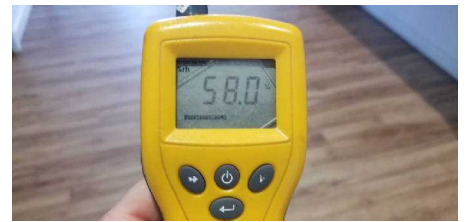
3. Gym Building Assessment Temp/Humidity Condition Elevated Relative Humidity - RH above 55% in any indoor space is considered "inappropriate" according to EPA and ACGIH guidelines. Elevated RH raised Dew Point and creates more condensation on cool surfaces, which can provide moisture source needed to support mold growth.

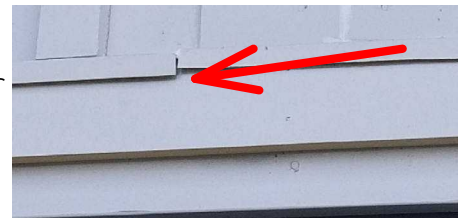
4. Gym Building Assessment Adjacent Exterior Exterior Wall Evaluation - Z flashing at upper wall skirt board at rear was improperly installed with no lap or sealant at the lap. Water intrusion occurs at this location causing the staining at rear wall.

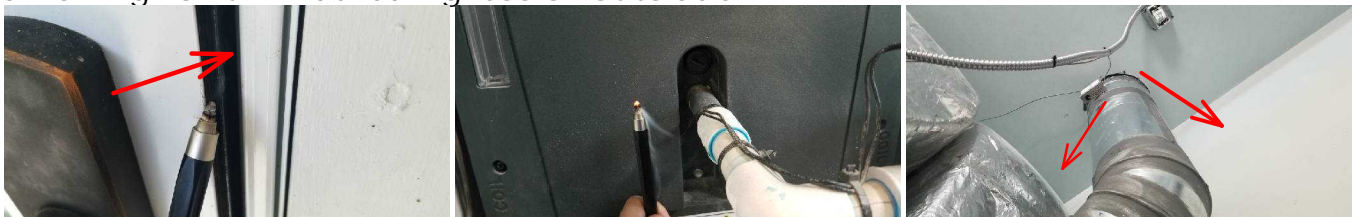
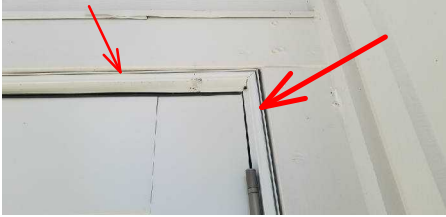
5. Gym Building Assessment Other Observations General Pressurization - Overall building pressurization was tested using a smoke pin to identify general tendencies for air movement either inward or outward. A consistent tendency towards inward air movement or negative pressurization was observed.

Exterior door casings were generally found to be unsealed and improperly installed allowing for unhindered ingress of outside air.
